Early Days at the Disaster: The World Trade Center After Sept. 11

BY PATRICK J. MCNIERNEY, P.E.

Ed. Note: This article recounts Patrick McNierney's participation in events at the World Trade Center site immediately following the attacks on September 11, 2001. It also deals with his connections, some through his family, with the work that went on there before and after the attacks. A briefer version of this article appeared in the on-line publication, Architecture Week, for December 5, 2001.

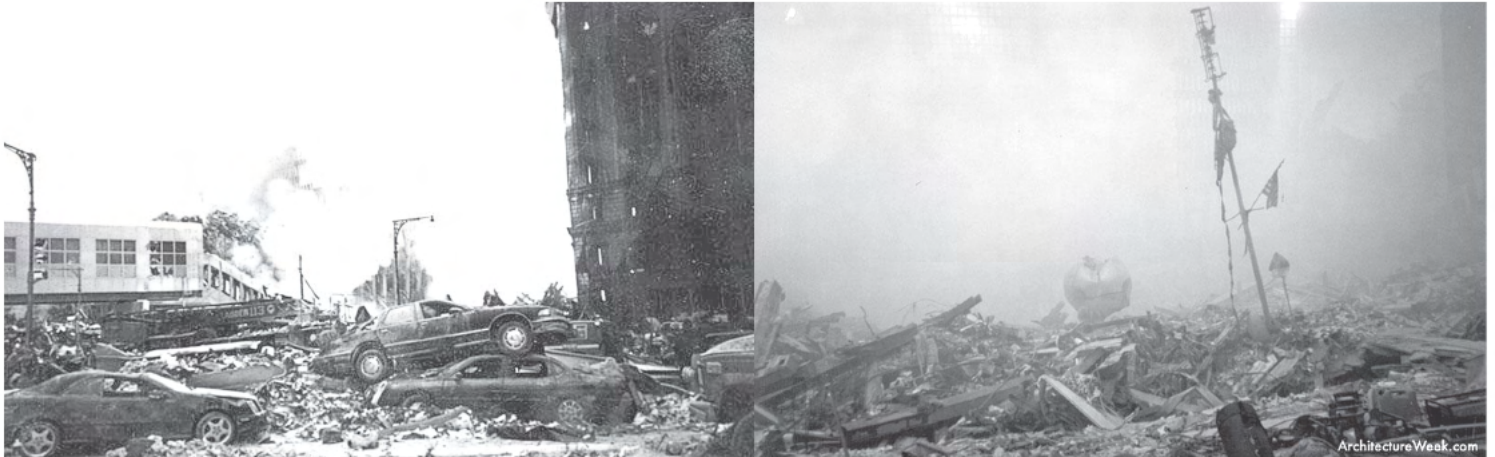
Photos show destruction caused by collapsing towers.

Picture at right shows lightning rod from top of north tower standing just above World Trade Center plaza.

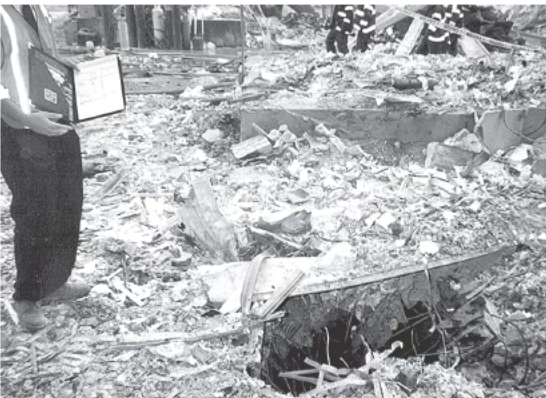
(Above) Sketch of the plaza drawn by author for construction workers in dust on car hood.

I suggested to the contractor responsible for the loader that portions of the sidewalk be chopped out in order to evacuate anyone below. I drew for him a sectional view of the area, indicating the staircase and plaza above. From vivid childhood memories, I remembered a foundation wall that extended from grade level down to bedrock. But I wasn't sure of the horizontal distance between it and the towers. A call to my father assured me that it was closer to the center of the Plaza than to Church Street.

Based on my sketch, three holes, each about 8 feet (2.5 meters) square, were dug that night directly above the main corridors below, giving access for rescue workers.
